SURFACE WATER MONITORING AND SURFACE WATER DELINEATION LOCATIONS

Leviathan Mine Site

Alpine County, California

Figure 2

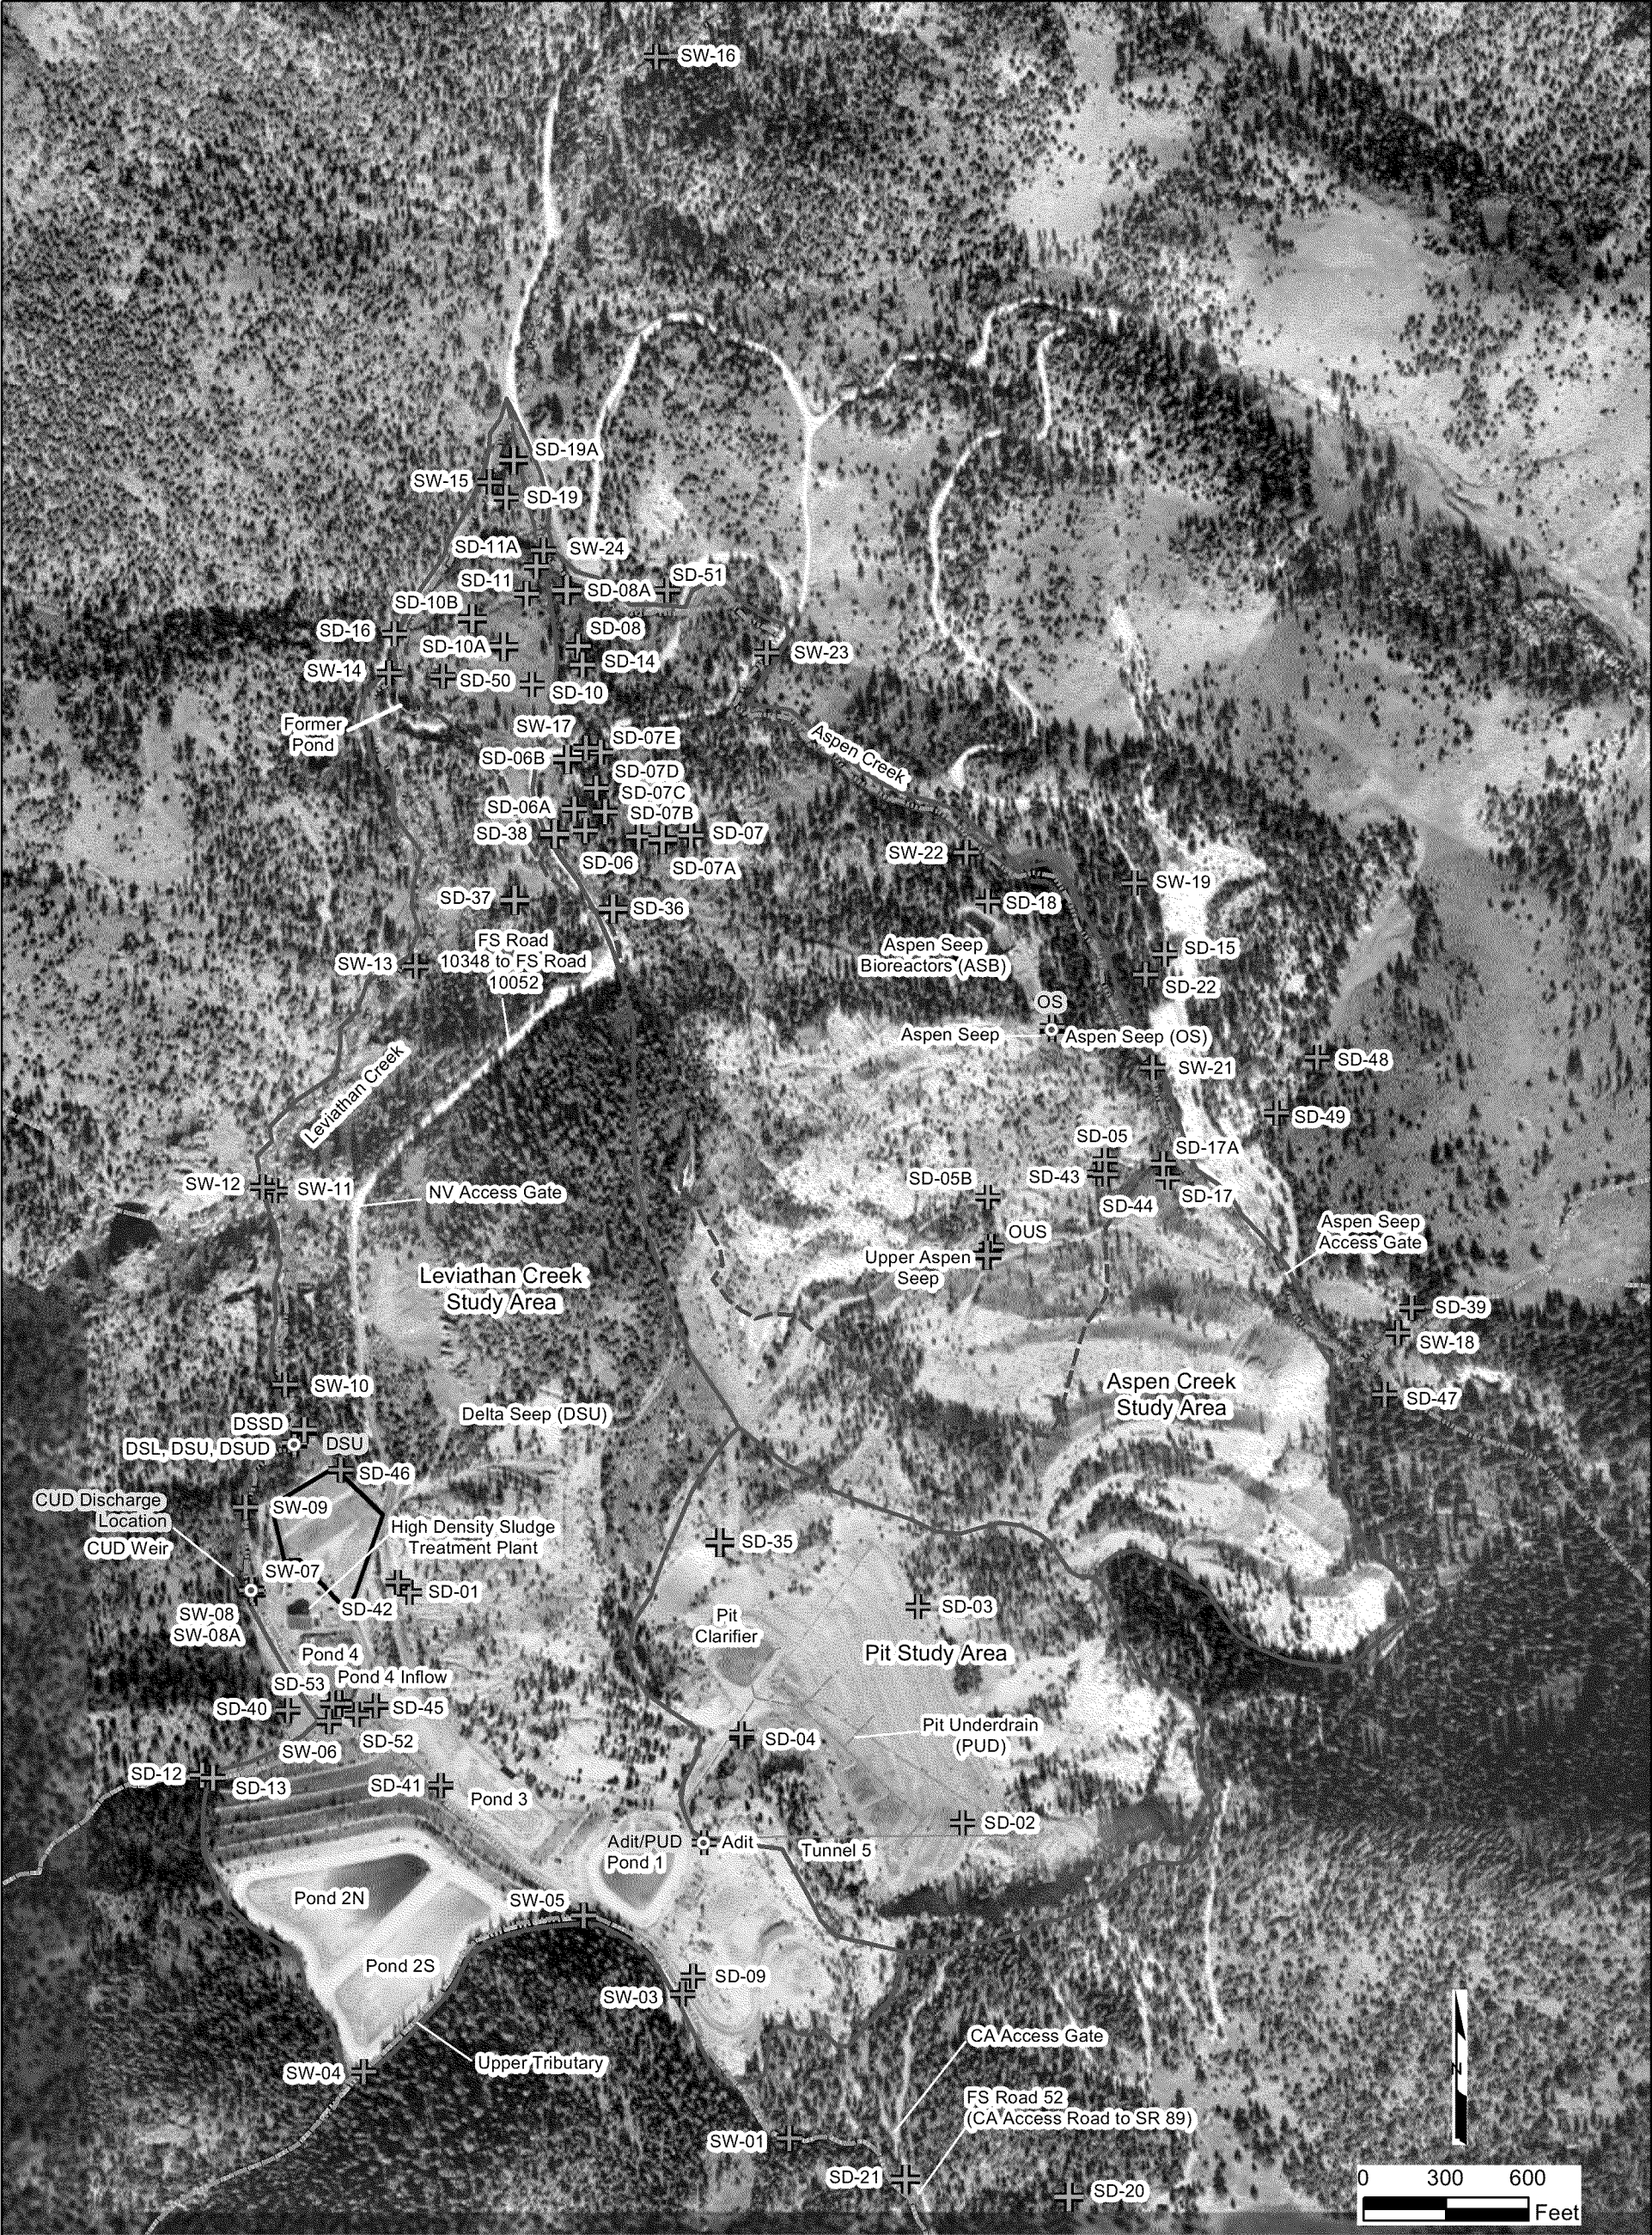
- On-Property Surface Water Delineation Locations Established in 2011/2012
- On-Property Surface Water Delineation Locations Established in 2017
- On-Property Surface Water Monitoring Locations
- Discharge Point
- Leviathan Creek Basin Landslide
- Creek
- Study Area
- Pit Underdrain Features

- All locations and boundaries are approximate.
- Base map from aerial photograph dated October 22, 2009.
